Test Report #	19A-000771-3	Date of Report Issue:	March 11, 2019
Date of Sample Received:	March 1, 2019	Pages:	Page 1 of 28
PRODUCT DESIGNATION:	9 WHITE LED TORCH		
BRAND NAME:	N/A		
MODEL NAME:	KC6860, MO8559, MO8680		
WODEL NAME.			
CLIENT:	Mid Ocean Brands B.V.		
DATE OF ISSUE:	March 11, 2019		
STANDARD(S):	EN 55015:2013+A1:2015, EN	61547:2009

1. VERIFICATION OF CONFORMITY

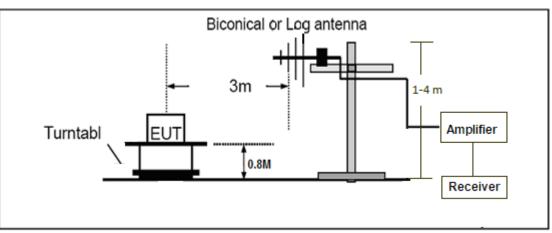
8.2. BLOCK DIAGRAM OF TEST SETUP

System Diagram of Connections between EUT and Simulators

- (1) The equipment was set up as per the test configuration to simulate typical actual usage per the user's manual. When the EUT is a tabletop system, a wooden turntable with a height of 0.8 meters is used which is placed on the ground plane as per EN 55015 (see Test Facility for the dimensions of the ground plane used). When the EUT is a floor-standing equipment, it is placed on the ground plane which has a 3-12 mm non-conductive covering to insulate the EUT from the ground plane.

- (5) The antenna was placed at 3 meters away from the EUT as stated in EN 55015. The antenna connected to the Analyzer via a cable and at times a pre-amplifier would be used.

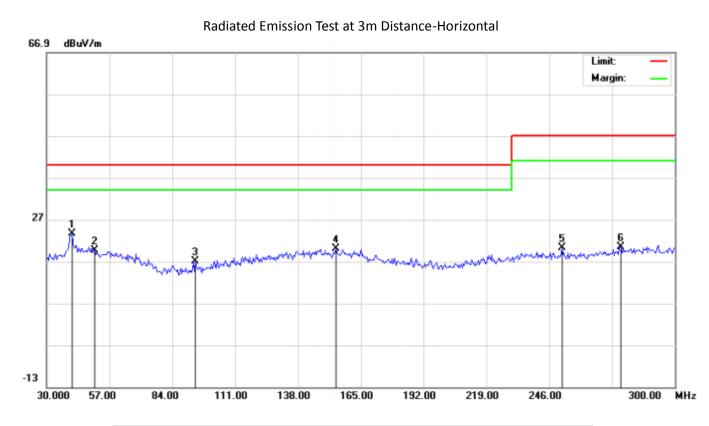
8.4. TEST RESULT OF RADIATED EMISSION TEST

No.	Mk	Freq.	Reading	Factor	Measurement	Limit	Over	Detector
	•	MHz	dBuV	dB/m	dBuV <i>I</i> m	dBuV/m	dB	
1	٠	40.8000	3.56	20.06	23.62	40.00	-16.38	peak
2		50.7000	-0.08	19.67	19.59	40.00	-20.41	peak
3		93.9000	1.67	15.38	17.05	40.00	-22.95	peak
4		154.2000	0.79	19.20	19.99	40.00	-20.01	peak
5		251.4000	1.70	18.46	20.16	47.00	-26.84	peak
6		276.6000	0.73	19.66	20.39	47.00	-26.61	peak

RESULT: PASS

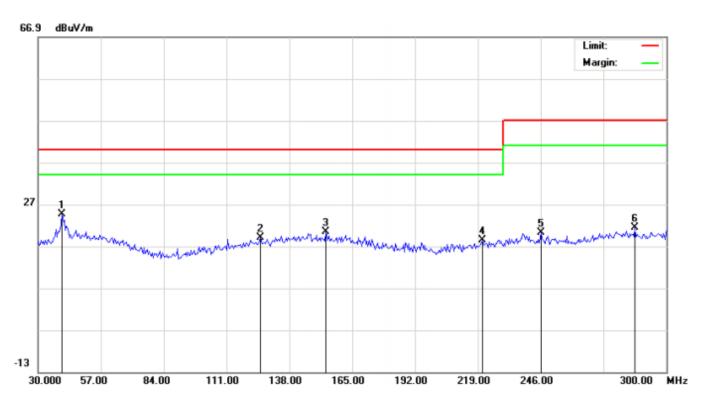
Radiated Emission Test at 3m Distance-Vertical

No.	Mk	Freq.	Reading	Factor	Measurement	Limit	Over	Detector
	•	MHz	dBuV	dB/m	dBuV <i>I</i> m	dBuV/m	dB	
1	*	40.3500	4.45	20.08	24.53	40.00	-15.47	peak
2		125.4000	0.71	18.31	19.02	40.00	-20.98	peak
3		153.7500	1.25	19.20	20.45	40.00	-19.55	peak
4		220.8000	1.07	17.30	18.37	40.00	-21.63	peak
5		246.0000	1.60	18.56	20.16	47.00	-26.84	peak
6		286.5000	1.57	19.79	21.36	47.00	-25.64	peak

RESULT: PASS

Measurement (dBuV/m)=Reading(dBuV)+Factor(dB/m)

Factor(dB/m)=Antenna Factor(dB/m)+Cable loss(dB)+Attenuation(dB)for Attenuator

Over= Measurement-Limit

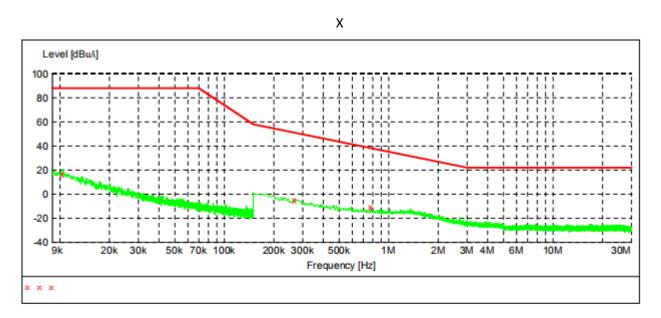
9.4. TEST RESULTS OF RADIATED ELECTROMAGNETIC DISTURBANCE

Frequency MHz	Level dBuA	Transd dB	Limit dBuA	Margin dB	Det.	Loop
0.010360	16.50	2.8	88	71.5	PK	x
0.267000	-5.10	-24.7	51	56.2		x
0.780000	-11.20	-30.8	38	49.4		x

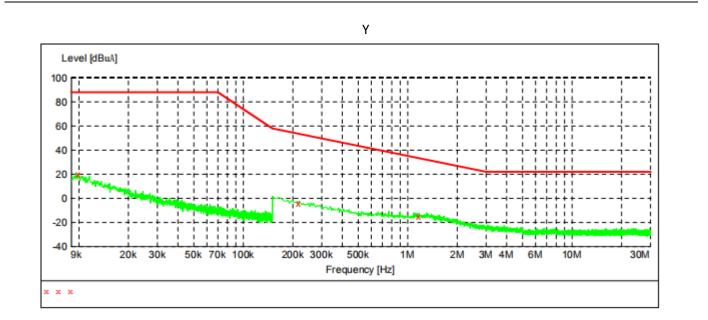
Frequency MHz	Level dBuA	Transd dB	Limit dBuA	Margin dB	Det.	Loop
0.009960	20.10	3.0	88	67.9	PK	Y
0.217500	-4.10	-23.2	54	57.6	PK	Y
1.176000	-15.00	-32.1	33	48.3	PK	Y

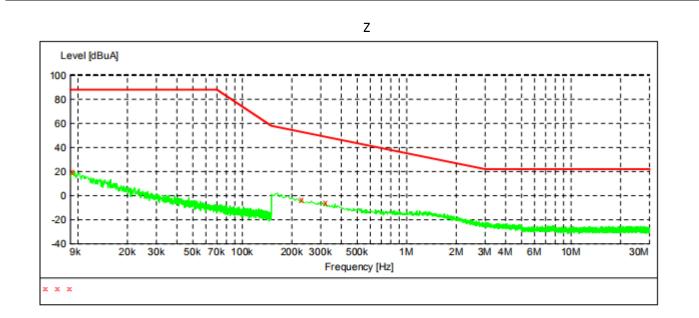
Frequency MHz	Level dBuA	Transd dB	Limit dBuA	Margin dB	Det.	Loop
0.009320	20.20	3.0	88	67.8		Z
0.231000	-3.60	-23.6	53	56.4		Z
0.321000	-5.50	-26.1	49	54.4		Z

RESULT: PASS

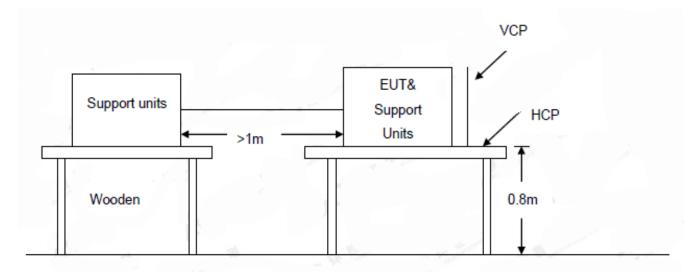
10.1. BLOCK DIAGRAM OF TEST SETUP

(The 470 k ohm resistors are installed per standard requirement)

Ground Reference Plane

The EUT was located 0.1 m minimum from all side of the HCP.

Note: As per the A2 to EN 61000-4-2, a bleed resistor cable is connected between the EUT and HCP during the test.

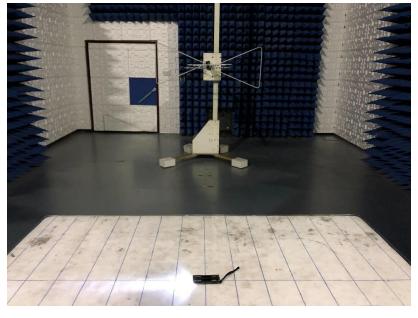
EN 55015 RADIATED EMISSION TEST SETUP

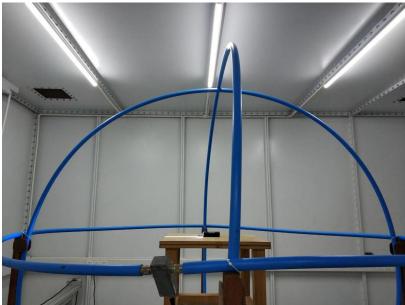
EN 55015 RADIATED ELECTROMAGNETIC DISTURBANCE TEST

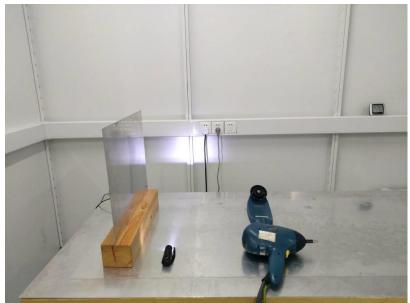
EN 61000-4-2 ESD IMMUNITY TEST SETUP

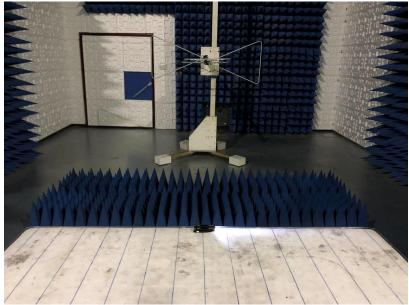
EN 61000-4-3 RS IMMUNITY TEST SETUP

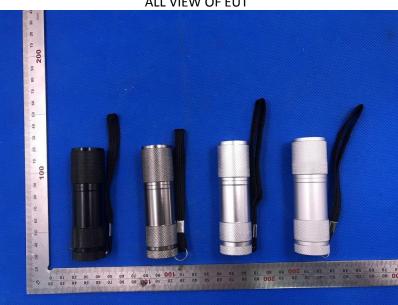
ALL VIEW OF EUT

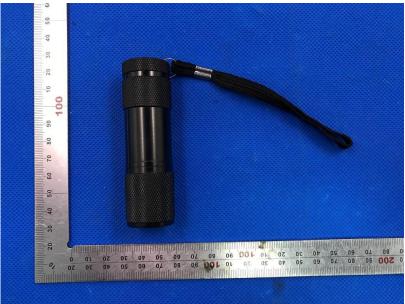
TOP VIEW OF EUT

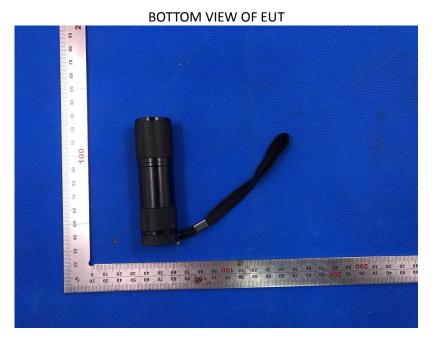
FRONT VIEW OF EUT

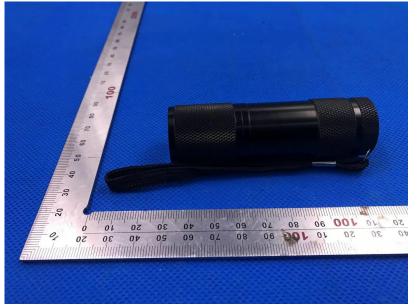
BACK VIEW OF EUT

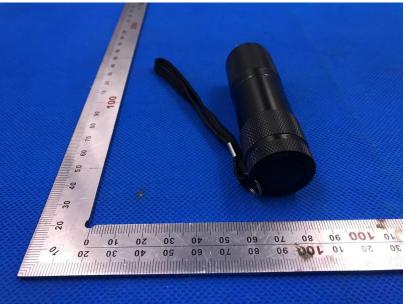
LEFT VIEW OF EUT

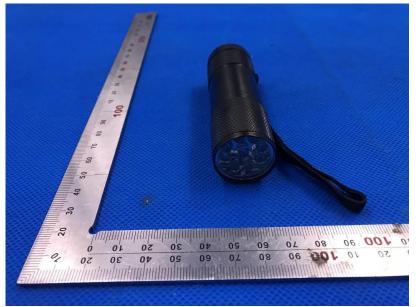
RIGHT VIEW OF EUT

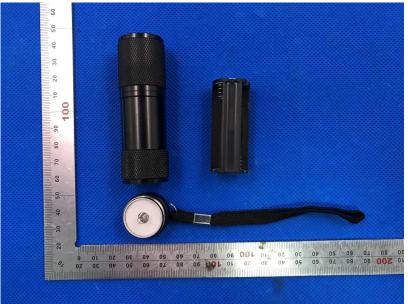
OPEN VIEW OF EUT

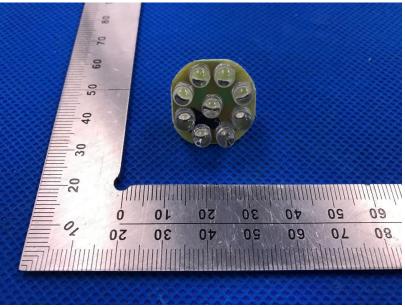
INTERNAL VIEW OF EUT-2
