Test Report #	19A-000747-3	Date of Report Issue:	March 7, 2019
Date of Sample Received:	March 1, 2019	Pages:	Page 1 of 28
PRODUCT DESIGNATION:	Safety light with multi tools		
BRAND NAME:	N/A		
MODEL NAME:	M08901		
CLIENT:	Mid Ocean Brands B.V.		
DATE OF ISSUE:	March 7, 2019		
STANDARD(S):	EN 55015:2013+A1:2015, EN	N 61547:2009

# The EMC testing has been performed on the submitted samples and found in compliance with the council EMC directive 2014/30/EU.

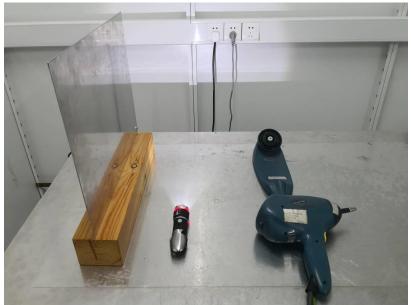
#### EN 55015 RADIATED ELECTROMAGNETIC DISTURBANCE TEST

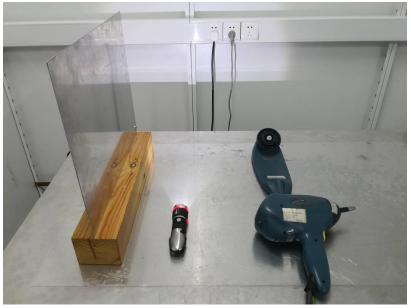
#### EN 61000-4-2 ESD IMMUNITY TEST SETUP

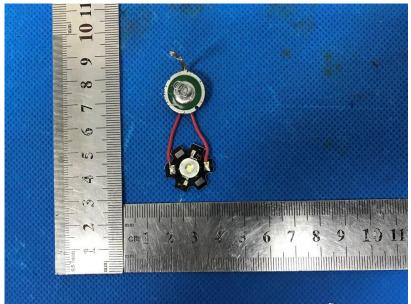
INTERNAL VIEW OF EUT-1
