# Test Report

Report No.: A001R20171103029S1

Sample Name : Cork key chain  
Model No. : MO9343  
Vendor code : 107978  
Country of origin : CHINA  
Country of destination : EUROPE  
Sample Receiving Date : Nov.03, 2017  
Testing Period : Nov.03, 2017 to Nov.16, 2017  
Test Requested : Please refer to next page(s).  
Test Method : Please refer to next page(s).  
Test Result : Please refer to next page(s).

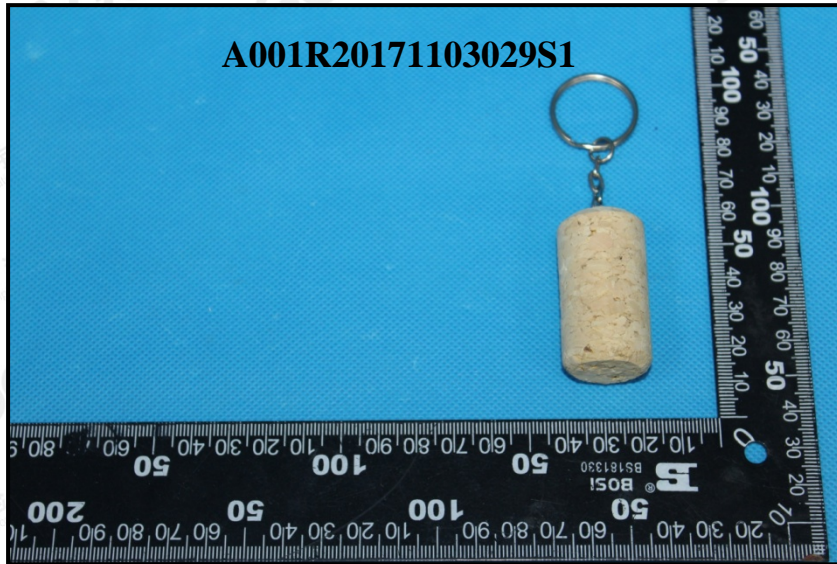
## The photo of the sample

| 1 | Cork |
| 2 | Metal ring |
| 3 | Metal chain |
