Test Report # 19A-000769-1 Date of Report Issue: March 4, 2019

Product Name: Pen shape multitools

Model/style No.: MO8559

Regulation (EC) No. 1907/2006 REACH Annex XVII, Item 63 Lead in Substrate Materials

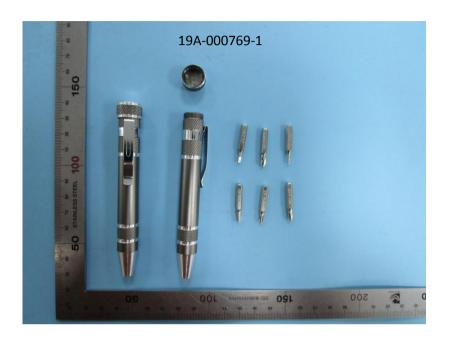
SAMPLE PHOTO:

Specimen No.	Specimen Description	Location
1	Silvery metal	Main body
2	Silvery grey metal	Main body
3	Silvery metal	Head
4	Bright silvery metal	Clip
5	Silvery grey metal	Whorl
6	Silvery metal	Screwdriver
