TEST REPORT

Reference No. : WTF20F07042101F

Sample Name : Cappuccino cup and saucer

Test Requested : In accordance with Council of Europe Resolution 84/500/EC (2005/31/EC) and Regulation (EC) No 1935/2004.

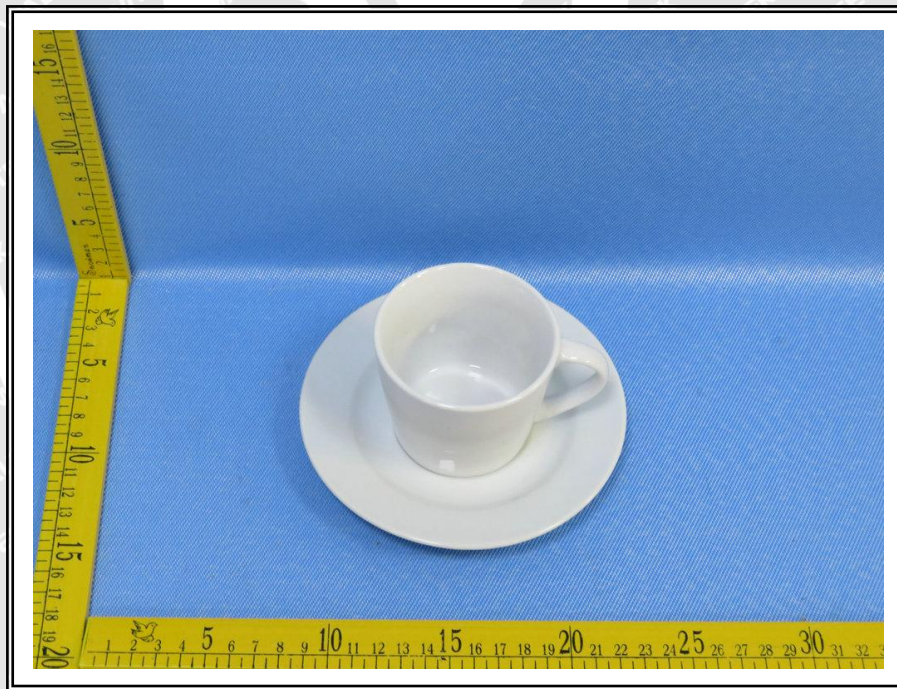
Sample Photo:

Model No. : MO9080

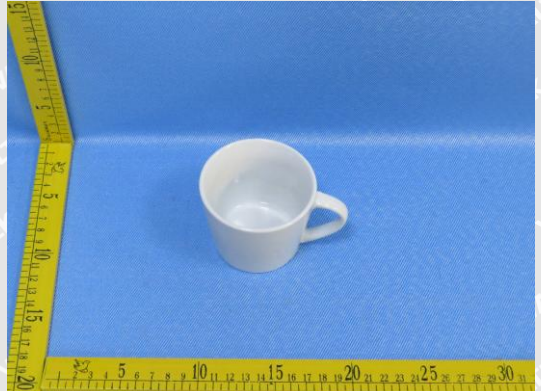
No.	Photo of testing part	Parts Description	Client Claimed Material
1

Test Items	Result (mg/L)	LOQ (mg/L)	Limit (mg/L)
	No.1		
Extractable Lead	ND	0.1	4.0
Extractable Cadmium	ND	0.01	0.3

White ceramic	Ceramic
