TEST REPORT

Reference No. : WTF20F03012366F
Applicant : Mid Ocean Brands B.V.
Address : 7/F., Kings Tower, 111 King Lam Street, Cheung Sha Wan, Kowloon, Hong Kong
Manufacturer : 114276
Sample Name : 780ml RPET bottle w/ SS lid
Model No. : MO9940
Test Requested : In accordance with Regulation (EU) No 10/2011 with amendments (EU) 2016/1416, (EU) 2017/752, (EU)2018/79, (EU)2019/37 and Regulation (EC) No 1935/2004.
Test Conclusion : **Pass** (Please refer to next pages for details)
Date of Receipt sample : 2020-03-23
Date of Test : 2020-03-23 to 2020-03-30
Date of Issue : 2020-03-30
Test Result : Please refer to next page (s)
Remark : Selected test(s) as requested by applicant.

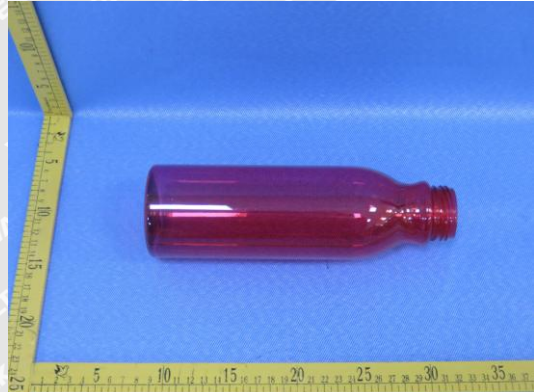
Photograph of parts tested:

No.	Photo of testing part	Parts Description	Client Claimed Material
1

Red plastic	RPET
